Project Name: FEATHERSOUND POND BANK STABILIZATION

Project Location:	Clearwater, Florida
Name of Owner:	Feather Sound Executive Centers Association
Dates of Construction:	April - May 2010

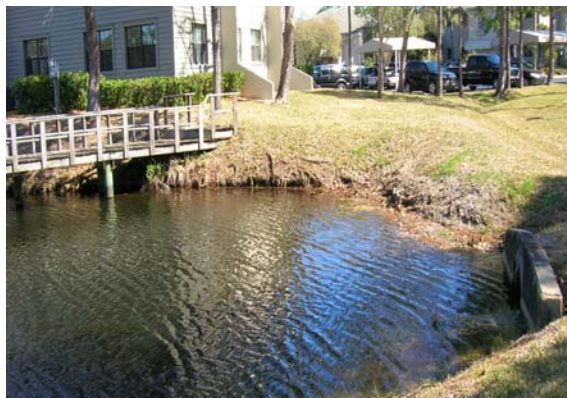
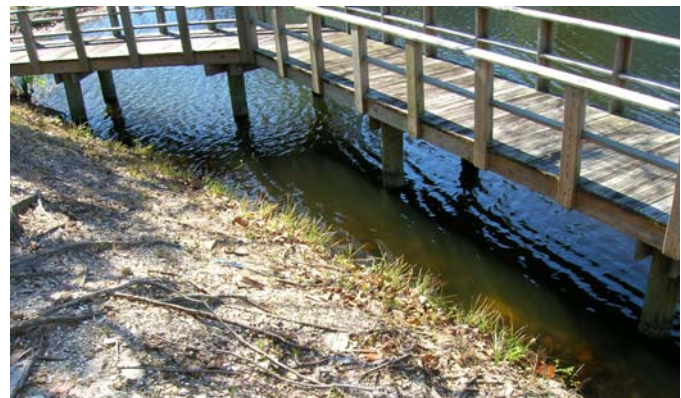
Before - Eroding Pond Bank

Necessary equipment and material was provided by Gator Dredging to successfully stabilize the eroding bank. Specialized mirafied geo synthetic fabric was used to line the bank of the pond in preparation for riprap to be installed. Crushed concrete was used for the riprap installation which completed the stabilization of the pond banks while creating an aesthetically pleasing setting for the Association.

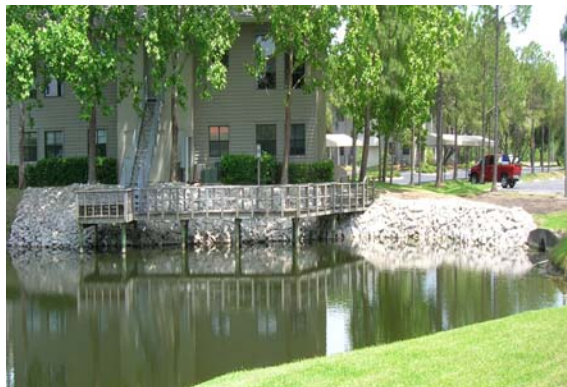
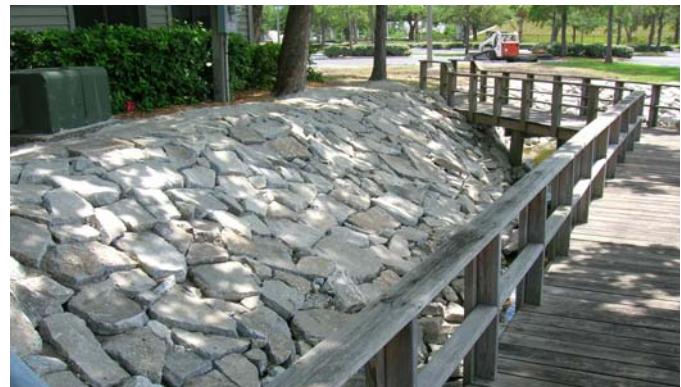
After - Rip Rap Installation
