Project Name: PEPPERTREE CONDOMINIUMS STORMWATER POND RESTORATION

SCOPE:

Project Location:	Sietsa Key, Florida
Name of Owner:	Peppertree Bay Condominiums
Dates of Construction:	April – June 2010

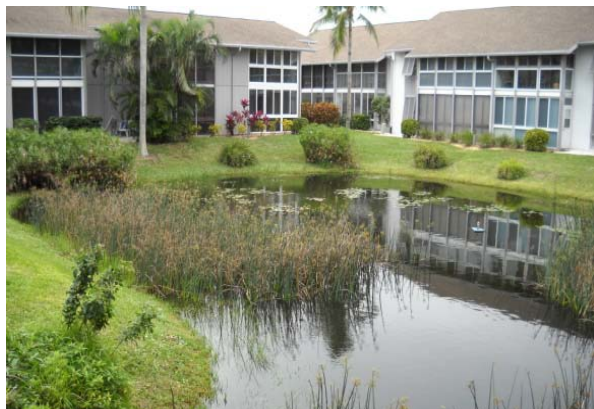
Pond 1 – Existing Conditions

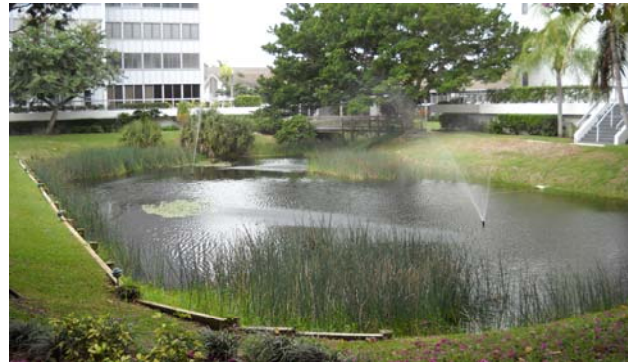
Pond 2 – Existing Conditions

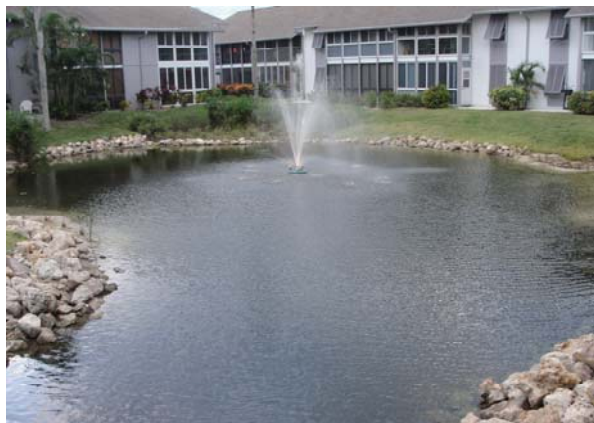
Pond 1 – Post Construction

This project included the dewatering and dredging of two adjacent ponds located within Peppertree Bay Condominiums. Once the ponds were drained, Gator Dredging mechanically removed and disposed of up to 18" of accumulated muck and nuisance vegetation from the two ponds to be restored to original dredge conditions.

The pond banks were then reinforced and stabilized with the installation of woven geotextile cloth and limestone rip rap, to re-slope and prevent future erosion of the banks. The geotextile cloth was placed at a width of 15 feet around the perimeter of the ponds, with a two foot layer of (6" – 12") limerock quarry stone centered on the average waterline. Gator Dredging regraded bank slopes to approximately 3:1 and installed over 80 tons of limestone rip rap for additional slope anchoring.

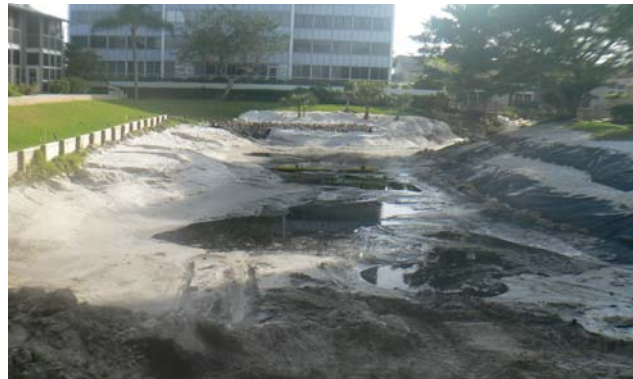
Pond 2 – Construction Phase

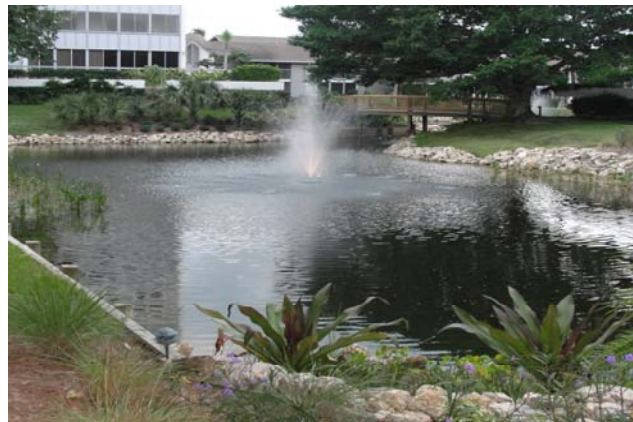
Pond 2 – Post Construction
