Project Name: SHIPWATCH CONDOMINIUMS POND RESTORATIONS

Project Location:	Largo, Florida
Name of Owner:	Shipwatch Condominiums
Dates of Construction:	June 2010 – January 2011

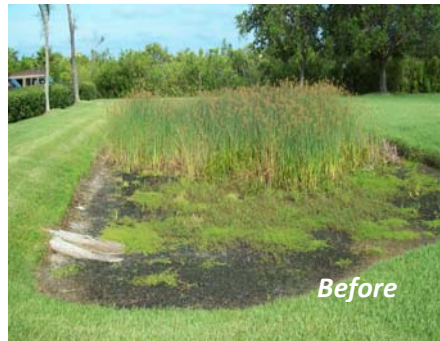
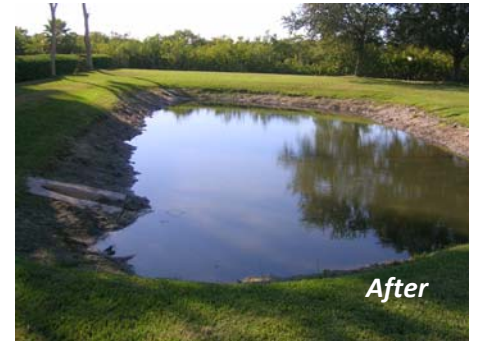
POND RESTORATION

This project included the restoration of three stormwater ponds throughout the Shipwatch community. Approximately 200 cubic yards of sediment was mechanically and hydraulically removed from the three stormwater drainage facilities and disposed of at a permitted upland disposal site.

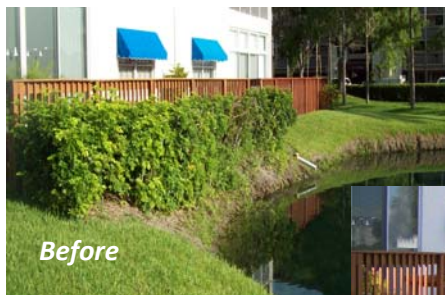
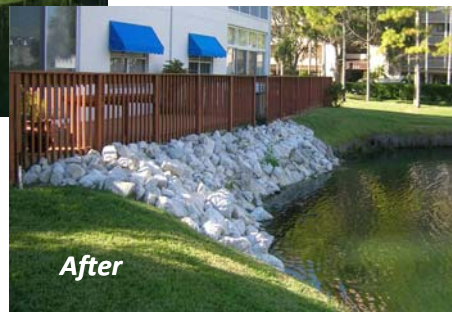
BANK STABILIZATION

Gator Dredging performed bank stabilization for one of the ponds, within the community, which had a failing bank. This included the installation of approximately 130 linear feet of geotextile liner and rip rap along the eroding portion of the pond bank. The installation of the 6” – 12” rip rap served as reinforcement to the bank slope area.

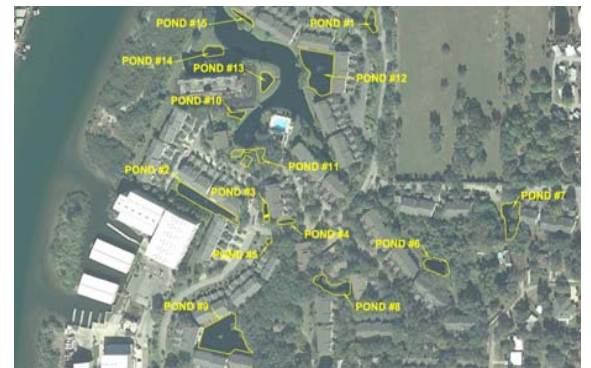
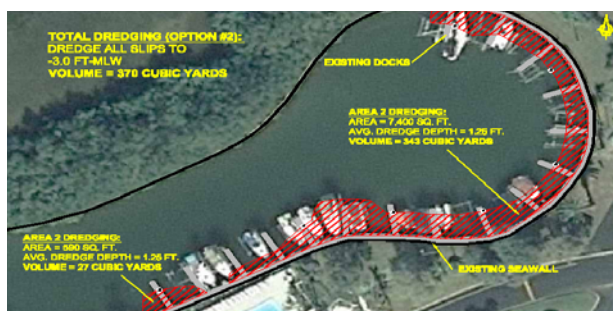
MARINA PERMITTING/DREDGING

The Engineers at Gator Dredging permitted the removal of approximately 2,400 cubic yards of sediment, located within the marina basin of Shipwatch. The material was hydraulically removed, pumped into custom fabricated dewatering tanks and disposed of at a permitted upland disposal site.
